Lime Staining of Brickwork

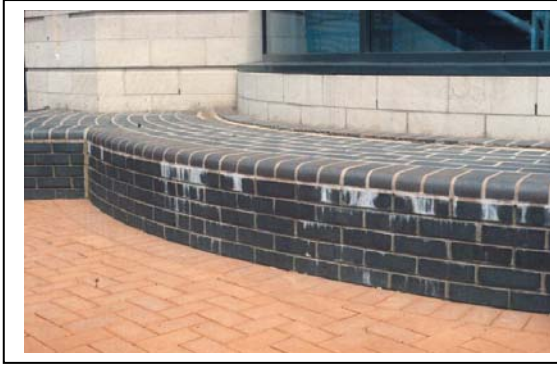
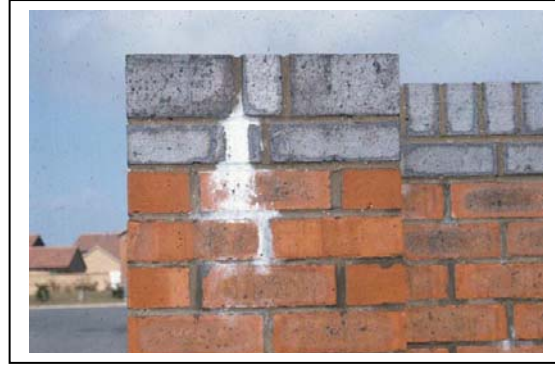
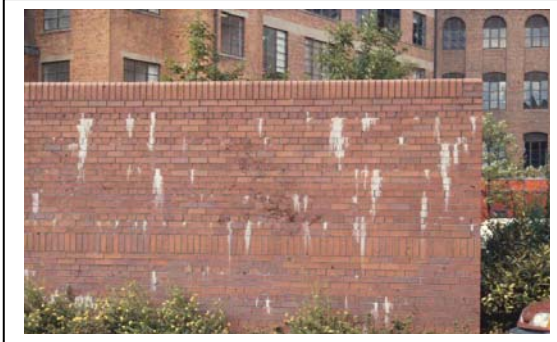
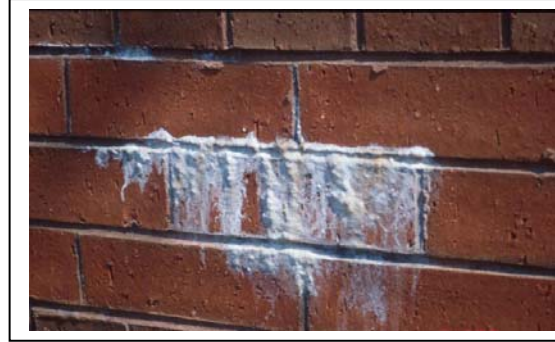
Lime staining is often mistaken as efflorescence, however, it usually emanates from mortar joints and doesn't disappear when wet.

Like efflorescence it needs saturation to transport the material, in this case free lime present in mortar or concrete and, as the water leeches out, it leaves the trailing effect shown above.

It is often clear where work has been left for the day without covering and a line of lime bleed-out staining appears where a downfall of rain has triggered the process.

Sometimes around weep-holes in new buildings a trail of lime can be seen forming where water has emerged after picking up material from cementitious matter left in the cavity or from floor slabs etc.

To remove fresh stains, scrub using a bristle brush and water, taking care not to damage the face of the bricks. For stains that have been exposed for longer and have started to carbonate, forming limestone, acid treatment is required.

Pre-dampen, not saturate, the wall to minimise its suction. Carefully apply a proprietary brick cleaning solution with a paint brush to dissolve the lime, then lightly scrub with a bristle brush and water.

If it hasn't disappeared after 3 attempts there is unlikely to be a significant improvement with further applications and specialist advice should be sought.
