## RAIN PENETRATION IN CLAY BRICKWORK WALLS

The outer leaf of Masonry construction is not watertight!

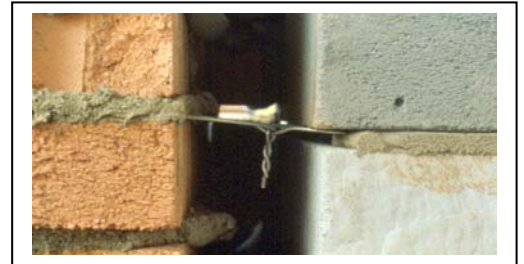
**Wall ties-** Wall ties are sandwiched within the mortar joints of each leaf and span the cavity gap to tie the structure together. Without these the walls may buckle in strong wind. If they are placed sloping downwards toward the inner leaf, water passing through the brickwork may travel down them causing damp spots on the inner wall.
