## EFFLORESCENCE

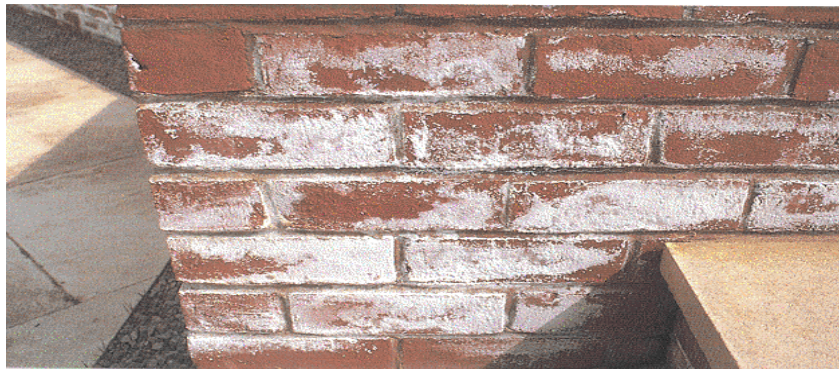
Visible as a harmless deposit of soluble material on the surface of brickwork, its texture may vary from light and fluffy to hard and glassy, depending on its composition. The deposits consist of natural occurring soluble salts which vary considerably throughout the country, not only within the clays used for the manufacture of bricks but also in the constituents necessary for the production of the mortar i.e. sand and cement.

Salts in brickwork are dissolved by the water which is introduced during construction or from rain. As the wall begins to dry out, the solution of salts becomes more concentrated and the dissolved salts will be deposited on the surface of the brickwork. This tends to be more prevalent at low temperatures, i.e. early Spring.
